# McClure Parcel B, Environmental Narrative Report

January 2019

Prepared for           KB Home Tampa Division  
Project Name           McClure Parcel B, Environmental Narrative Report  
Project Number        E215015905  
Project Manager       John Bailey  
Date                    January 2019

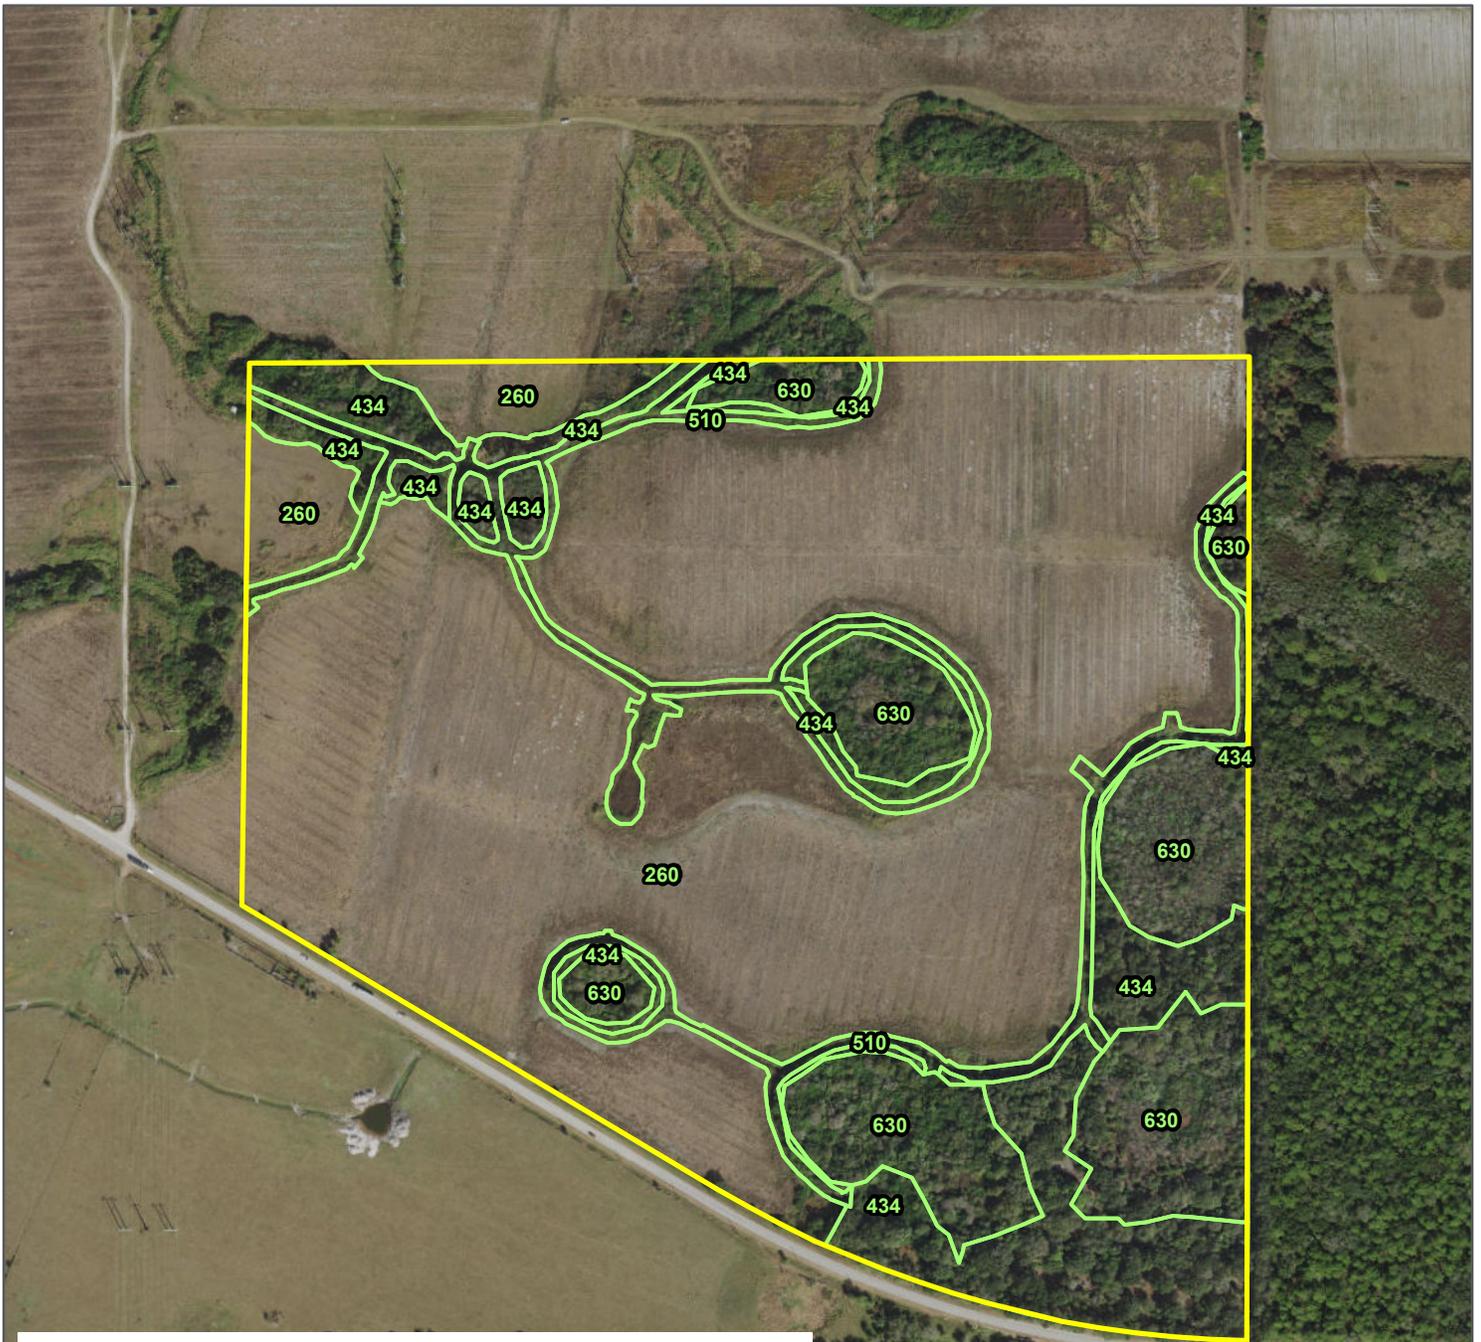
## Land Use Map

260 - OTHER OPEN LANDS <RURAL> - 85.78 ac. ±
-

434 - HARDWOOD CONIFER MIXED - 16.49 ac. ±
-

510 - DITCHES - 7.83 ac. ±
-

630 - WETLAND FORESTED MIXED - 18.86 ac. ±

Cardno inspected and mapped the onsite habitats and described each using the Florida Land Use Cover Forms and Classification System (FLUCFCS, Florida Department of Transportation 1999) (Land Use Map). The site conditions are detailed in the following paragraphs.

### Other Open Lands (FLUCFCS 260)

These areas dominate the land use within the Project Site. Overall, this habitat type consists of pasture grasses including Bahia grass (*Paspalum notatum*), smutt grass (*Sporobolus indicus*), and Bermuda grass (*Cynodon dactylon*). Other species include various broomsedges (*Andropogon* spp.), lantana (*Lantana strigocamra*), cogon grass (*Imperata cylindrica*), primrose willow (*Ludwigia octovalvis*), Caaserweed (*Urena lobata*), rag weed (*Ambrosia artemisiifolia*), dog fennel (*Eupatorium capillifolium*), and flat top goldenrod (*Euthamia caroliniana*).

### Hardwood Conifer Mixed (FLUCFCS 434)

These forested areas are generally associated with the mixed forested wetlands that occur within the Project site. Within this habitat type the canopy is dominated by laurel oak (*Quercus laurifolia*) and, to a lesser extent, slash pine (*Pinus elliotii*). Other canopy species include cabbage palm (*Sabal palmetto*), water oak (*Quercus nigra*), live oak (*Quercus virginiana*), and red cedar (*Juniperus virginiana*). The shrub

#### Ditches (FLUCFCS 510)

A network of upland-cut agricultural drainage ditches have been constructed throughout the property. At the time of the site survey, all ditches contained water, generally over 24-inches in depth. These ditches were dominated by cattail (*Typha latifolia*) and primrose willow (*Ludwigia peruviana*). Historically the ditches were constructed to provide hydrologic regime control and dewatering of the wetlands for the production of row crops. Six of the seven wetlands on the site have rim ditches, these are included within this habitat type. Because of the water depth and overgrown nature of the ditches, they do not provide suitable foraging habitat for wood storks.

#### Wetland Forested Mixed (FLUCFCS 630)

There are seven wetlands within the Project Site (Wetlands Map). In their current condition, the wetlands within the Project site have all been hydrologically altered by the drainage ditch network that was constructed to lower the water table on the property to improve its suitability for agriculture. The edge of the majority of the wetlands on the property consist of dense thickets of Brazilian pepper (*Schinus terebinthifolius*). The majority of the wetland have a canopy that is primarily dominated by red maple (*Acer rubrum*), but also contains species such as sweet bay (*Magnolia virginiana*), laurel oak, water oak, Chinese tallow tree (*Sapium sebiferum*) and cabbage palm. Shrub cover is moderate overall with pockets of very dense stands. The shrubs within the wetland consist of scattered shiny lyonia (*Lyonia lucida*), salt bush (*Baccharis halimifolia*), cabbage palm, elderberry (*Sambucus nigra* var. *canadensis*), and wax myrtle. The herbaceous vegetation within these systems consists of various ferns including chain fern (*Woodwardia virginica*), cinnamon fern (*Osmunda cinnamomea*), and swamp fern (*Blechnum serrulatum*). Along the outskirts of the wetlands, Boston fern (*Nephrolepis exaltata*) occurs within the herbaceous layer with dense stands of Brazilian pepper providing the dominant cover. At the time of the survey event, standing water was present and soils were mucky, moist, and hydric indicators including lichen lines, moss collars, and adventitious roots were observed.

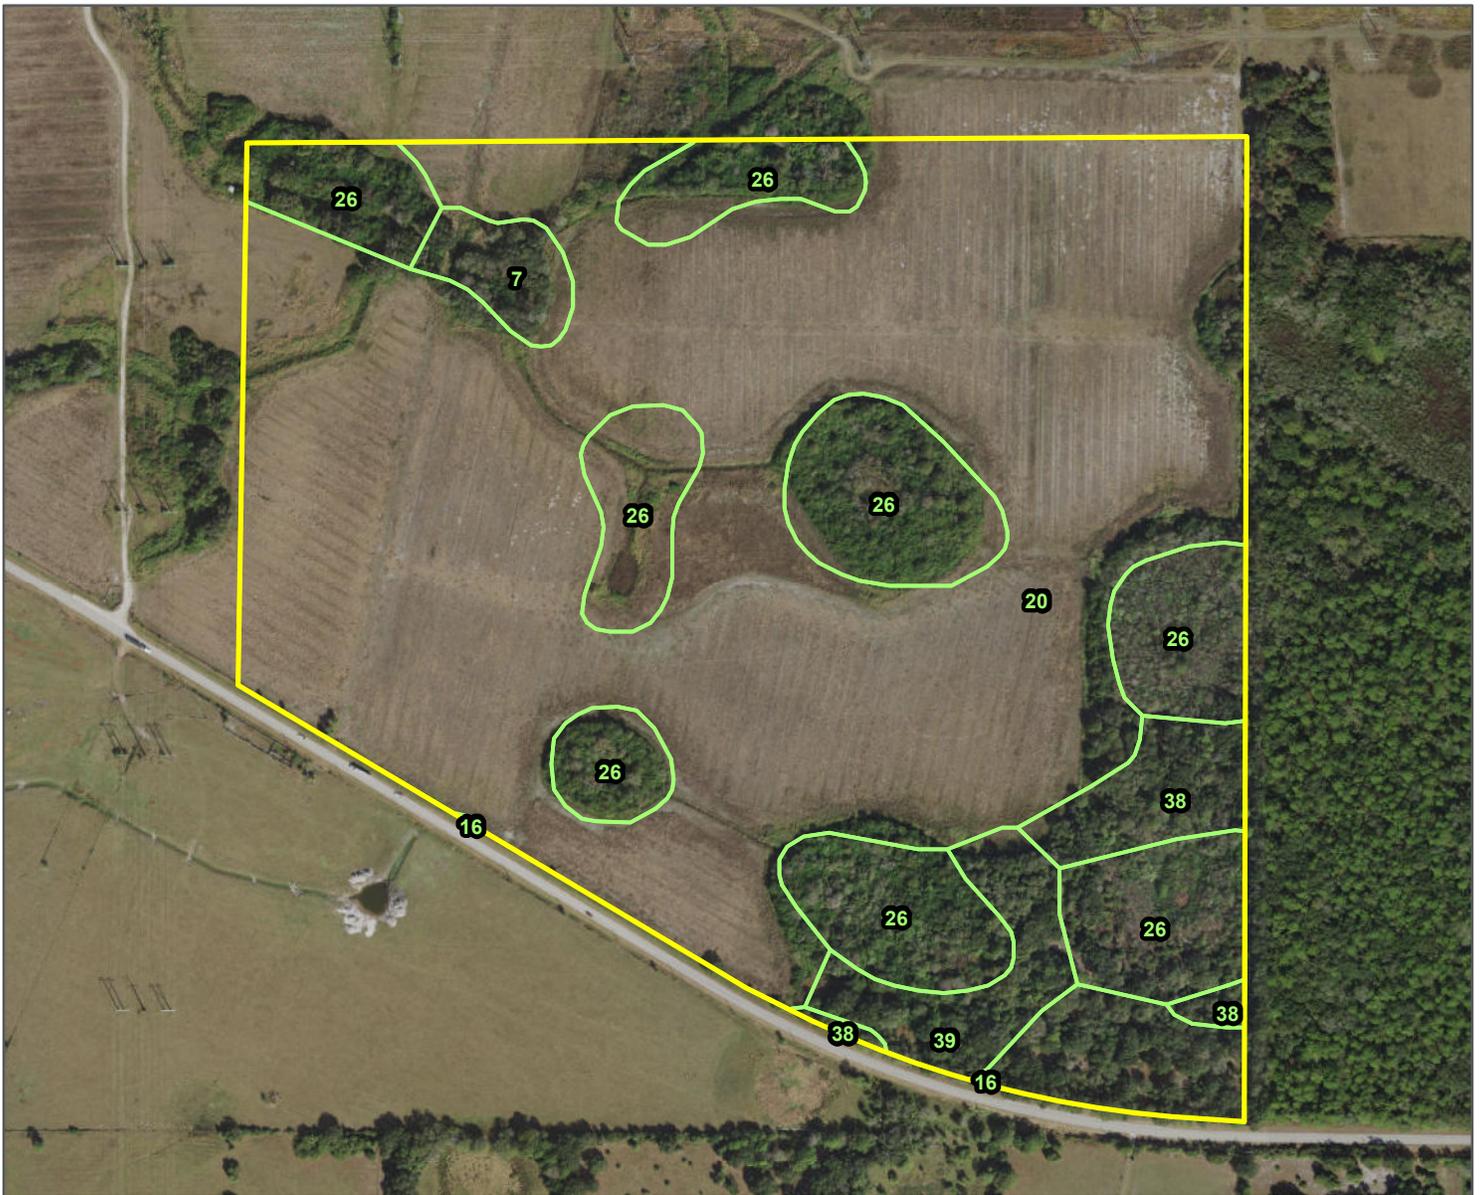
## NRCS Soils Map

- Project Boundary - 128.94 ac. ±
- 7 - CANOVA, ANCLOTE, AND OKEELANTA SOILS - 2.12 ac. ±
- 16 - DELRAY COMPLEX - 0.06 ac. ±
- 20 - EAUGALLIE FINE SAND, 0 TO 2 PERCENT SLOPES - 92.17 ac. ±
- 26 - FLORIDANA-IMMOKALEE-OKEELANTA ASSOCIATION - 26.67 ac. ±
- 38 - PALMETTO SAND - 3.73 ac. ±
- 39 - PARKWOOD VARIANT-CHOBEE, LIMESTONE SUBSTRATUM-PARKWOOD COMPLEX - 4.19 ac. ±

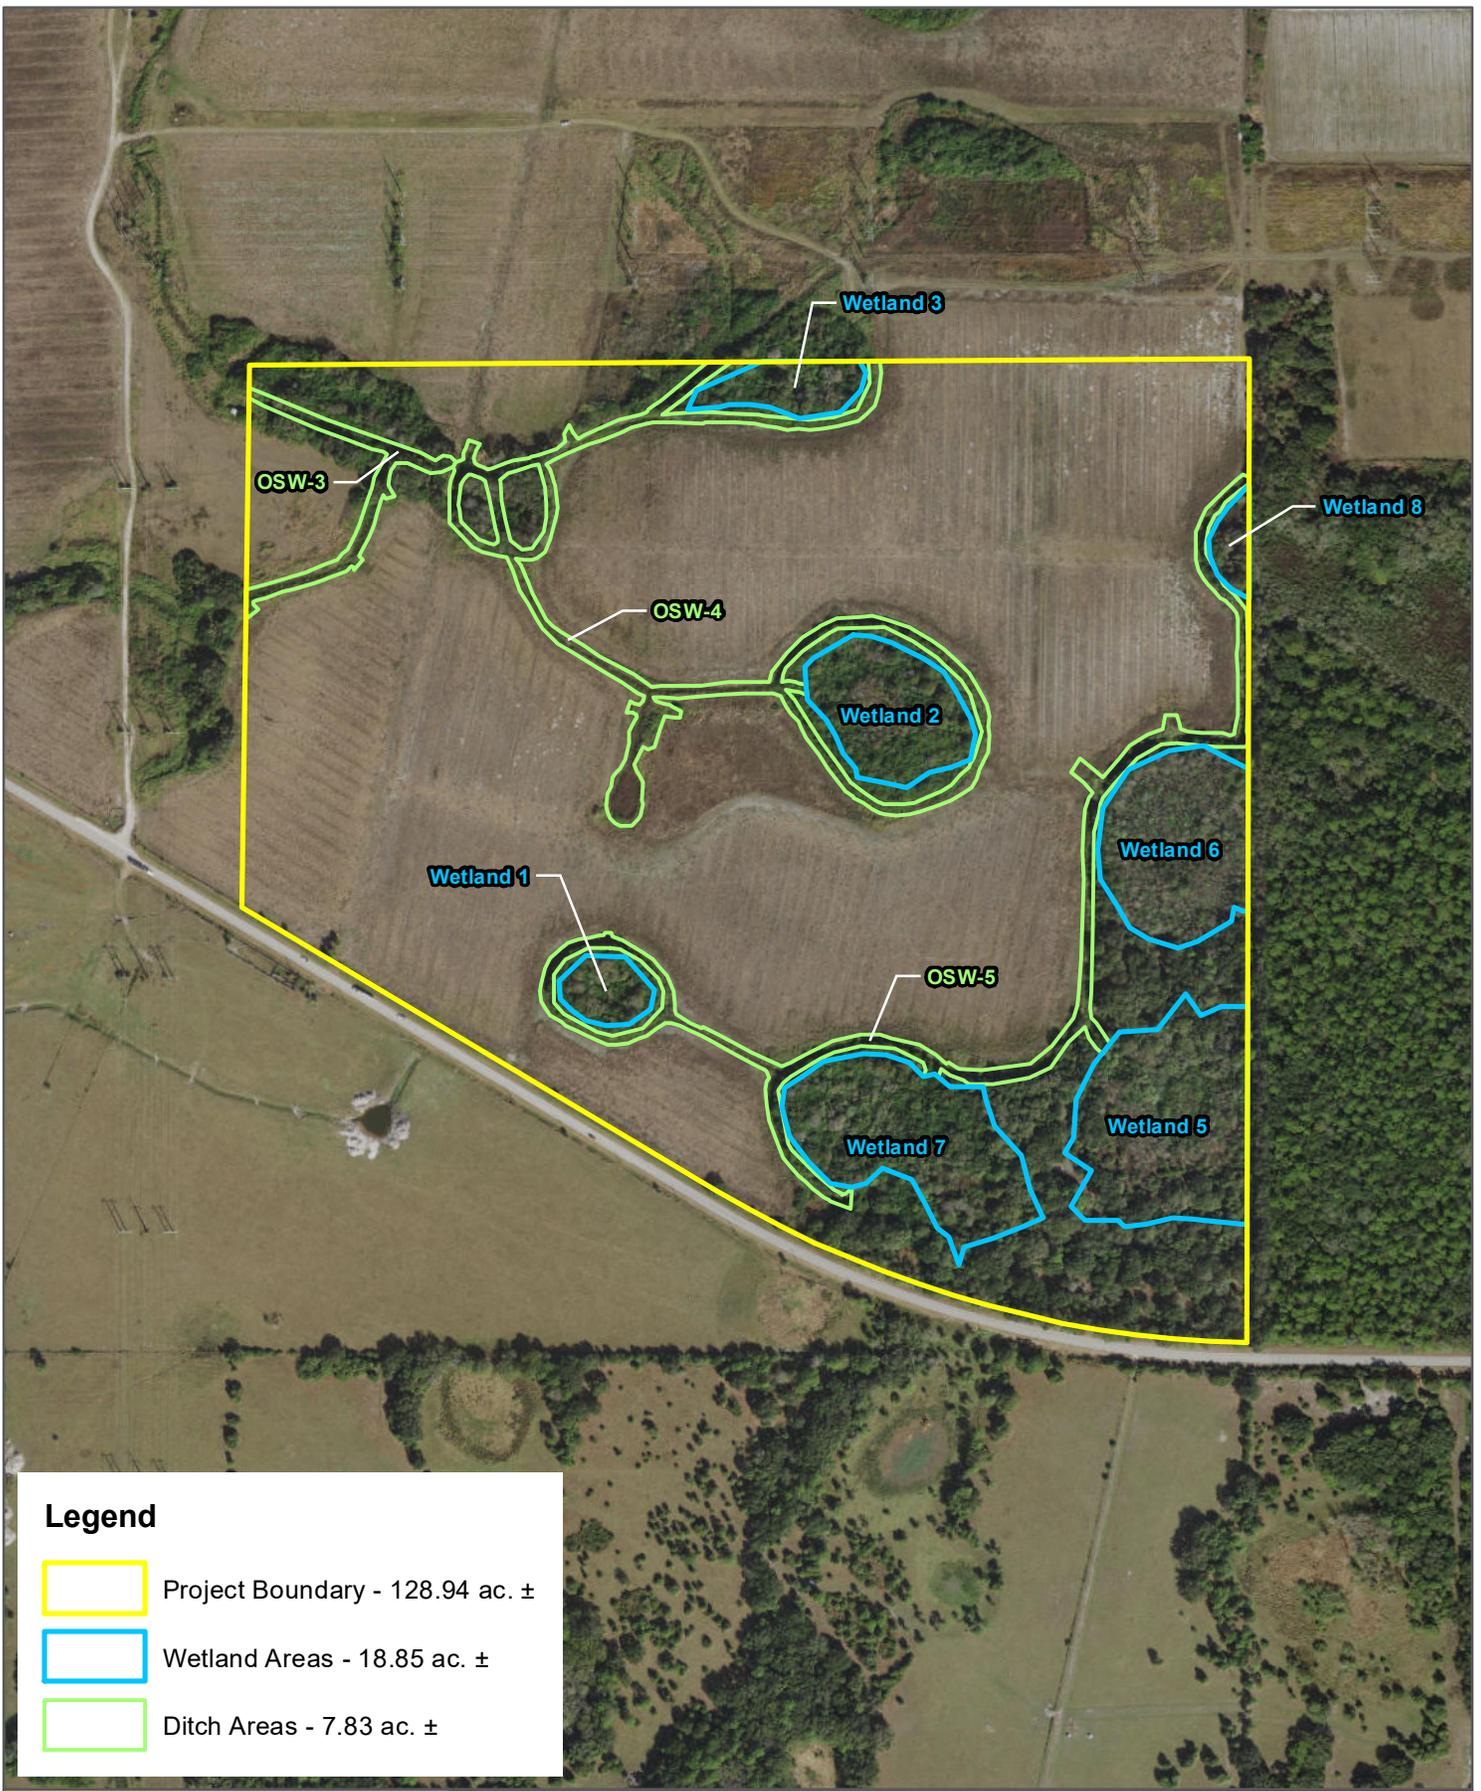
**Wetland Map**  
 McClure Moccasin Wallow Property - Parcel B  
 Manatee County, Florida

- Project Boundary - 128.94 ac. ±
- Wetland Areas - 18.85 ac. ±
- Ditch Areas - 7.83 ac. ±

The project area is approximately 129 acres and is comprised of a mix of upland and wetland habitats. The Project Site is characterized as undeveloped lands, historically utilized for agriculture, particularly row crops. The site is bounded by undeveloped remnant historic agriculture fields and Moccasin Wallow Road at the southern property boundary. No regionally significant parks or preserves are present surrounding the Project Site. All wetlands on the site were delineated by Cardno based on the methodology included in FAC 62-340. The Cardno wetland boundaries were field reviewed and approved by the SWFWMD Formal Wetland Determination No. 42044458.000 issued December 23, 2019 and are shown on the attached Wetlands Map.

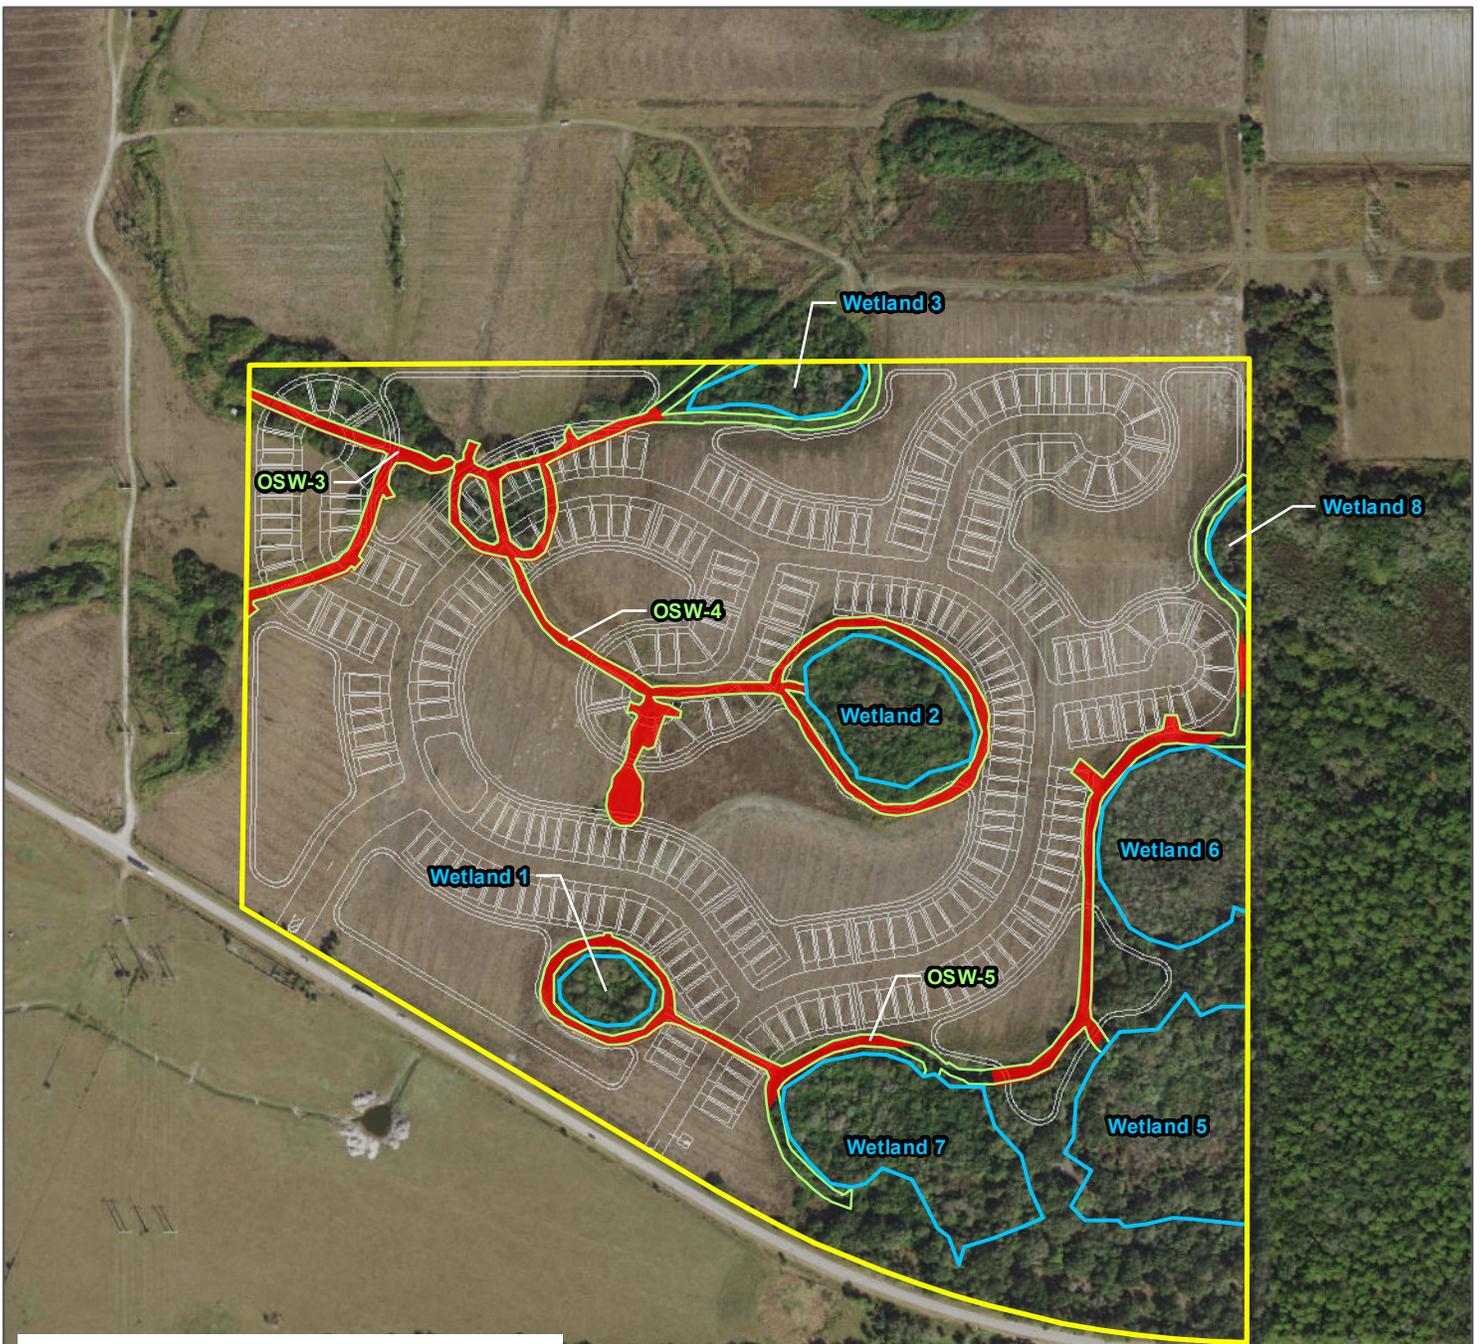
**Site Plan/Ditch Impacts Map**  
 McClure Moccasin Wallow Property - Parcel B  
 Manatee County, Florida

- Project Boundary - 128.94 ac. ±
- Wetland Areas - 18.85 ac. ±
- Ditch Areas - 7.83 ac. ±
- Ditch Impact Areas - 6.23 ac. ±
- Site Plan

This report was prepared by Cardno, Inc. (Cardno) on behalf of KB Home (Applicant) in order to provide the environmental information necessary to evaluate the project for conformance with permitting criteria of Manatee County Development Review Services and the Southwest Florida Water Management District (SWFWMD). This report describes the wetland and wildlife resources present on the project site and the measures taken to avoid and minimize impacts to wetlands to the extent practicable. No impacts to wetlands are required to construct the project. Approximately 6.23 acres of upland cut drainage ditches will be required to construct access roads and lots.

The Project Site is proposed as a single-family residential development with supporting infrastructure, and community amenities by KB Homes on approximately 129 acres. There is a total of approximately 18.85 acres of wetlands and 7.83 acres of upland cut ditches within the Project Site. All impacts to wetlands have been avoided in the development of the site plan. However, in order to construct the access roads and finish side slopes of some of the residential lots, approximately 6.23 acres of impacts to upland-cut drainage ditches will be required (Site Plan/Ditch Impact Map). It is not possible to develop an economically feasible project and avoid the drainage ditches. As described above, the ditches are overgrown with invasive species. Further, the filling of the drainage ditches will likely result in a hydrologic improvement to the wetlands.

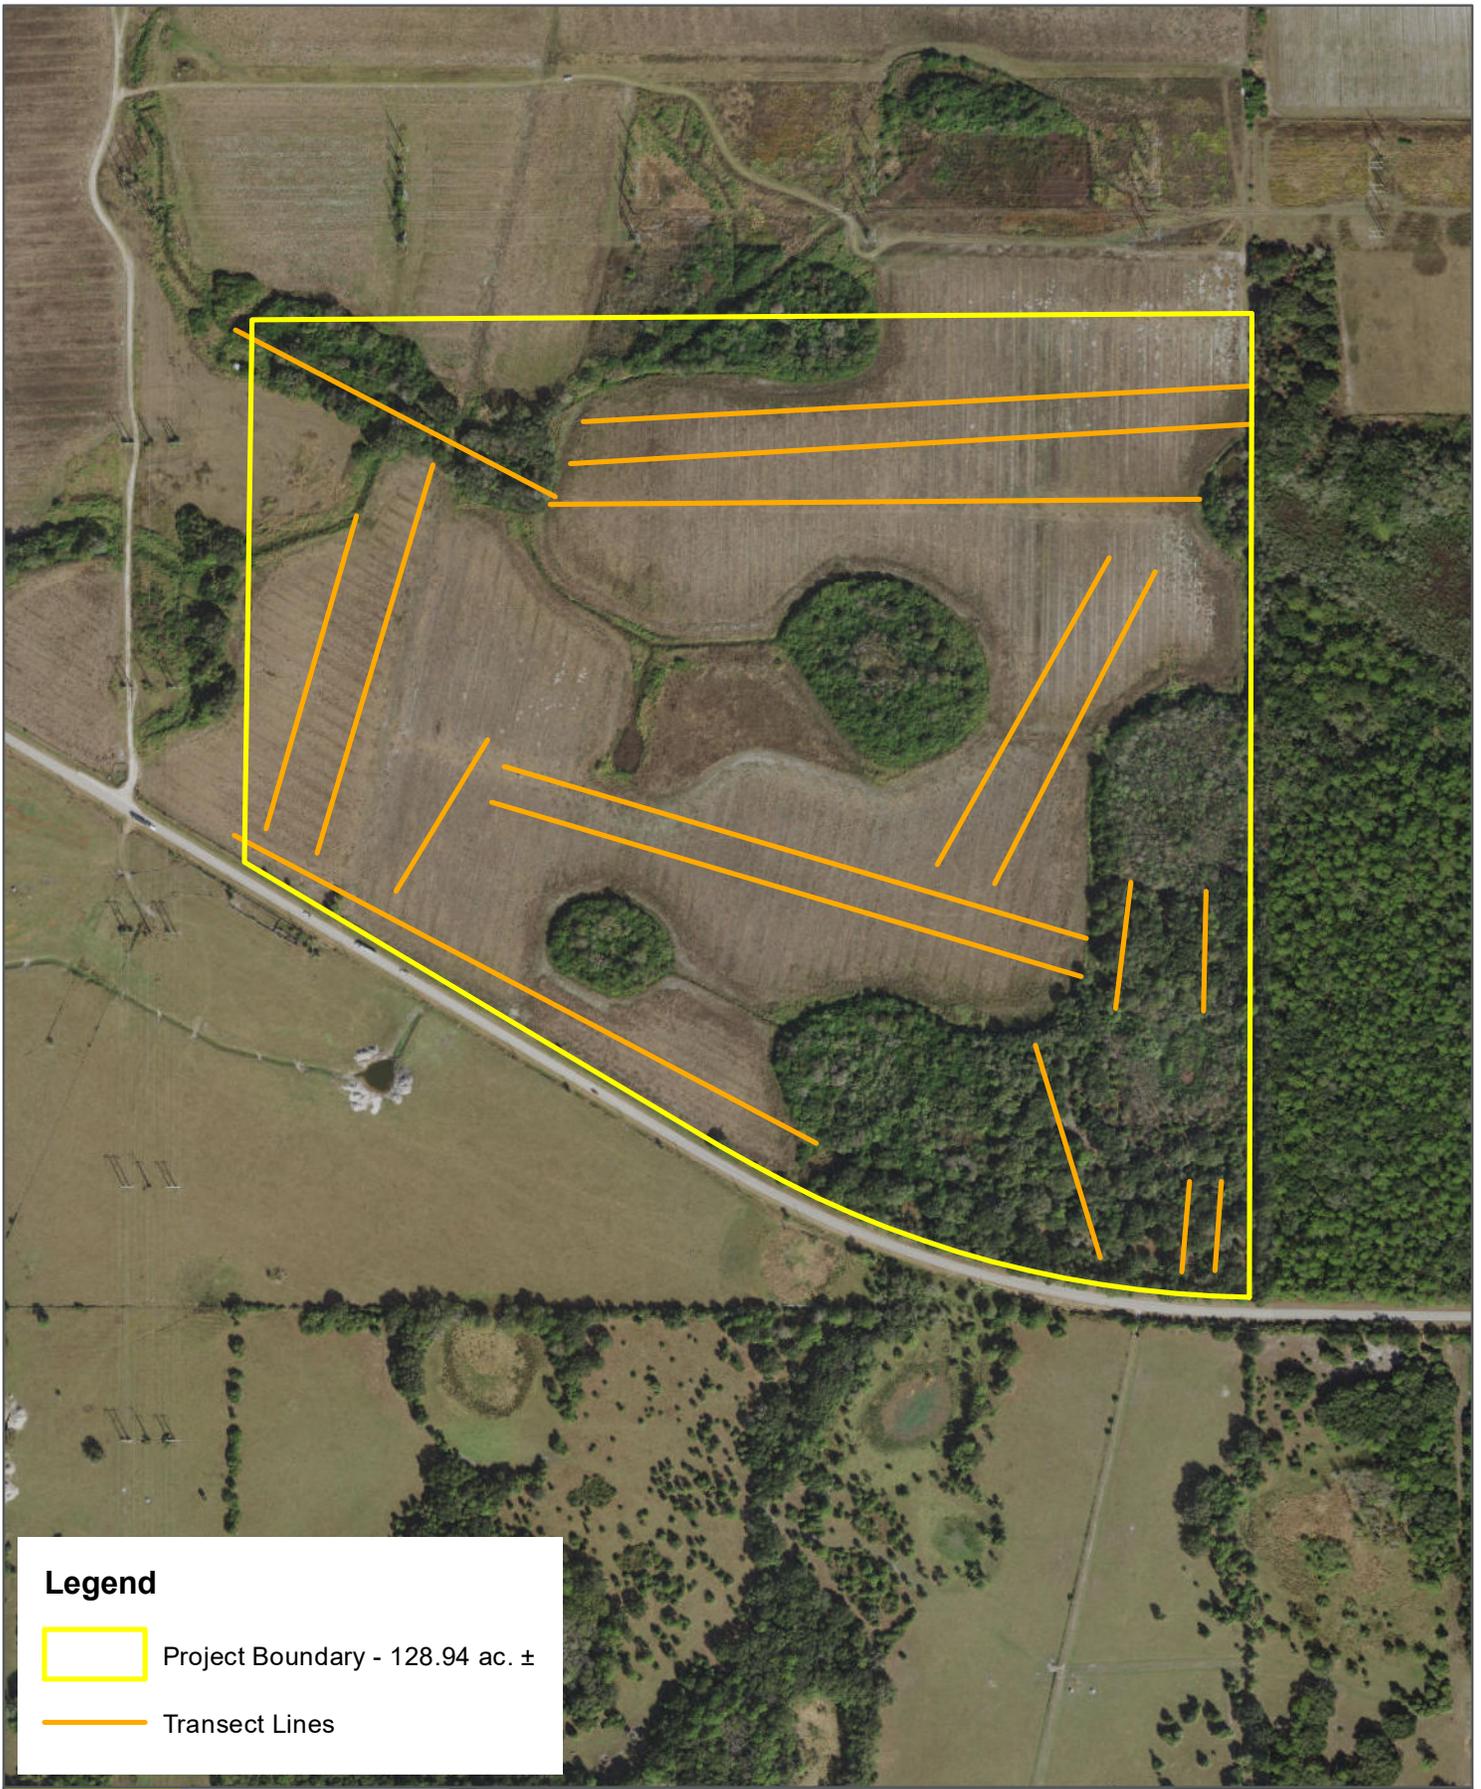
**15% GT Survey Map**  
 McClure Moccasin Wallow Property - Parcel B  
 Manatee County, Florida

Transect Lines

As part of the site review of upland and wetland habitats within the site, Cardno ecologists conducted a listed species survey consisting of meandering pedestrian transects and a 15 percent gopher tortoise survey. As many species are cryptic, particular attention was paid to cavities, snags, burrows, tracks, scat, etc. The 15 percent gopher tortoise survey was conducted by a Florida Fish and Wildlife Conservation Commission (FWC) Authorized Gopher Tortoise Agent from Cardno. No gopher tortoises or their burrows were observed. No other listed species or evidence thereof was observed during the site review. The following is a discussion of listed species with the potential to occur in the geographic area of the project site.
