Cresswind

Manatee County Preliminary Site Plan

Environmental Report

April 2017

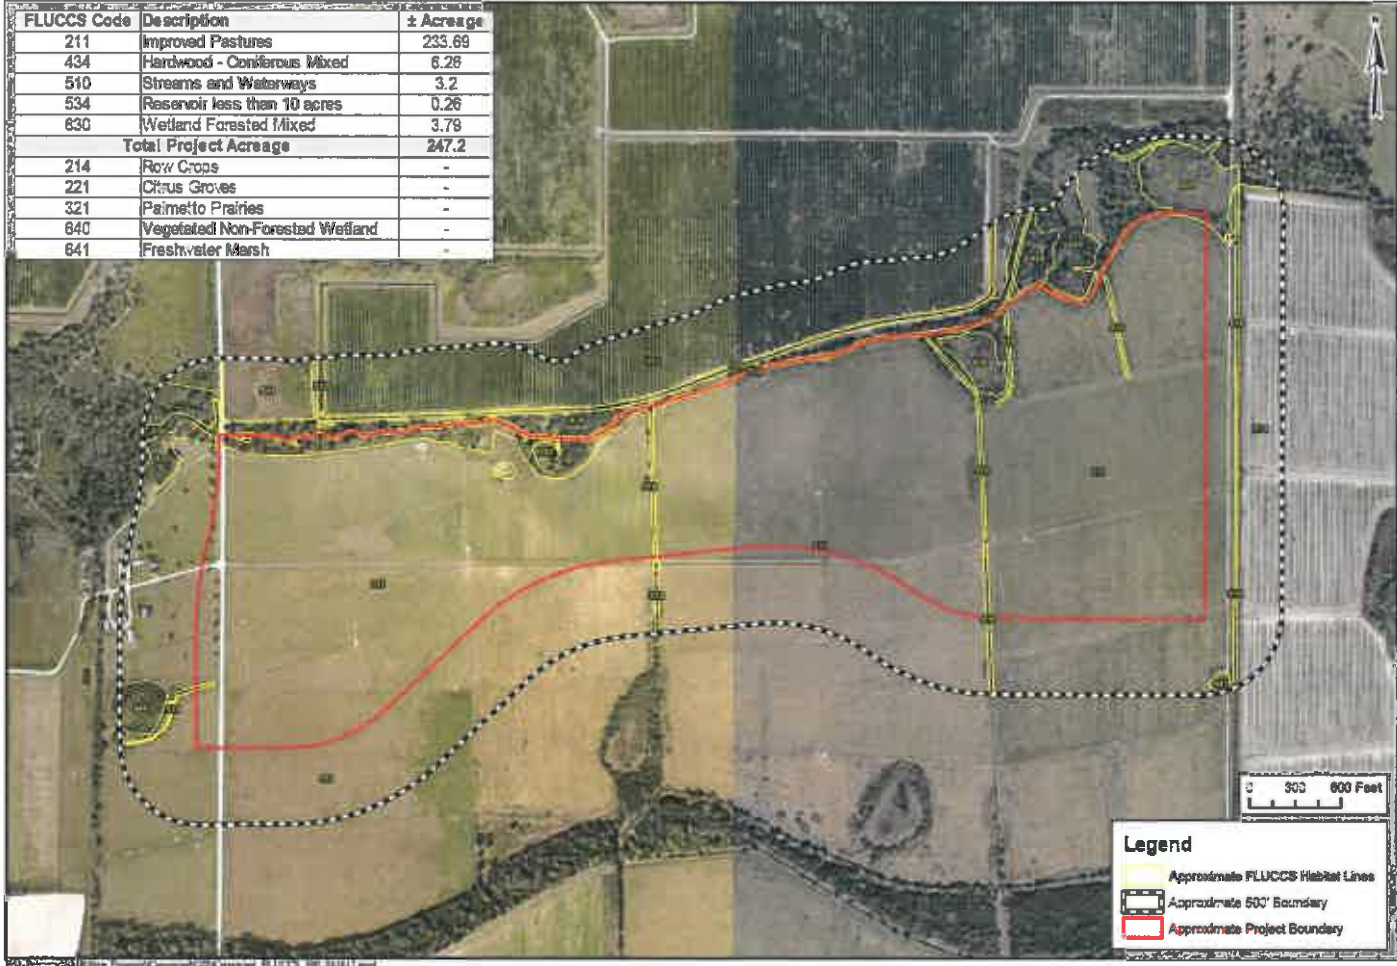
Client: Keller Homes
 Project: Oremfield
 Title: County FLUCCS Habitat Map

Legend

| | Approximate FLUCCS Habitat Lines |
| | Approximate 500' Boundary |
| | Approximate Project Boundary |

OFF-SITE WETLAND and OFF-SITE UPLAND HABITATS:
